# Your Inspection Report

Thursday, July 27, 2023

HomeBridge Inspections LLC  
Tacoma, WA 98409

RE: Report No. 2704, v.2

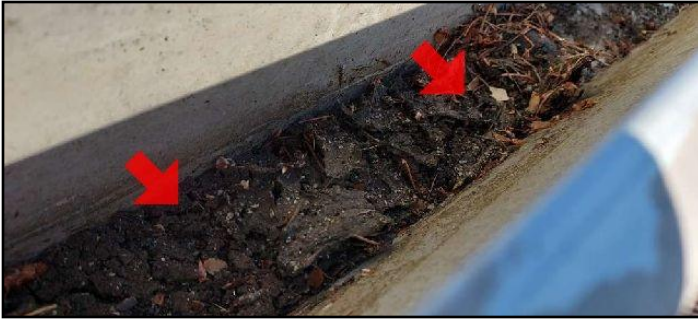
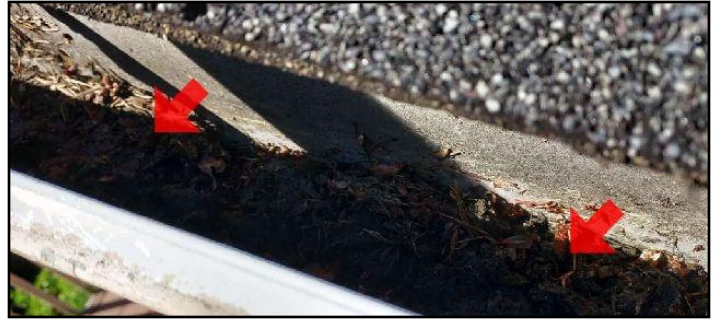
**1. Condition:** • Dirty/debris

**Implication(s):** Chance of water damage to building materials.

**Location:** Throughout Exterior

Dirty/debris

**Task:** Service / Clean

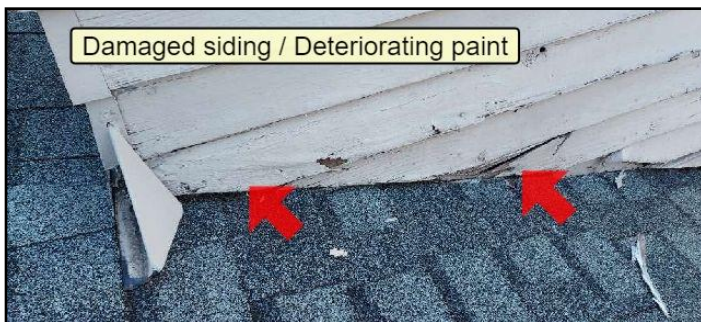
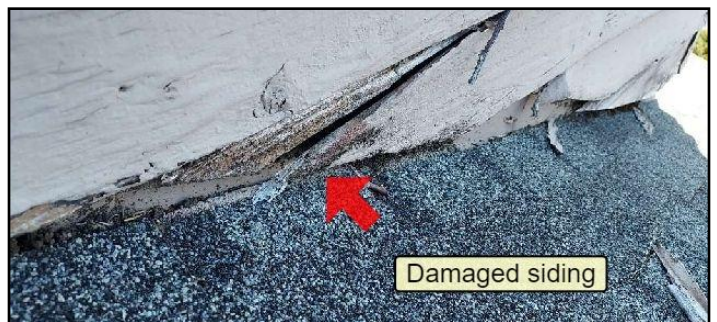
2. Condition: • Damage

Location: Exterior Wood Chimney

Damage

Task: Repair or replace

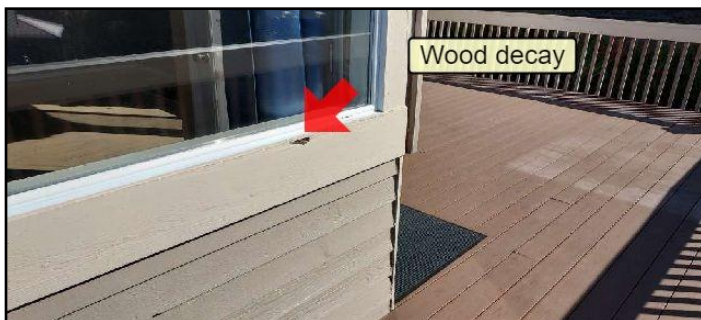
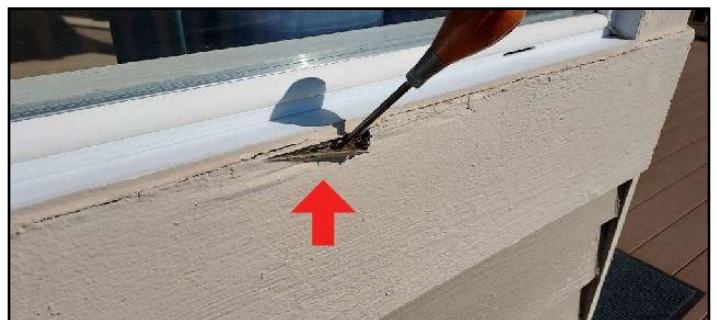
3. Condition: • [Rot](#)

Implication(s): Chance of water damage to structure, finishes and contents | Material deterioration

Location: Right Side Exterior

Rot

Task: Repair or replace

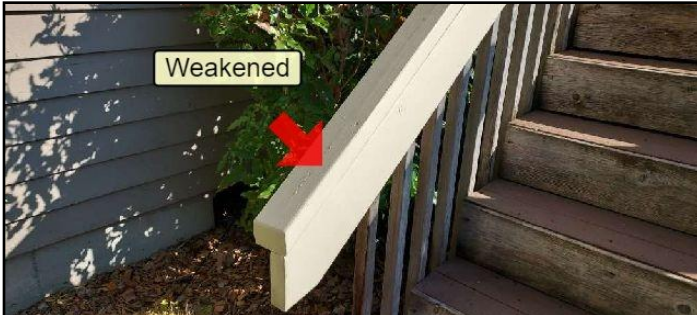
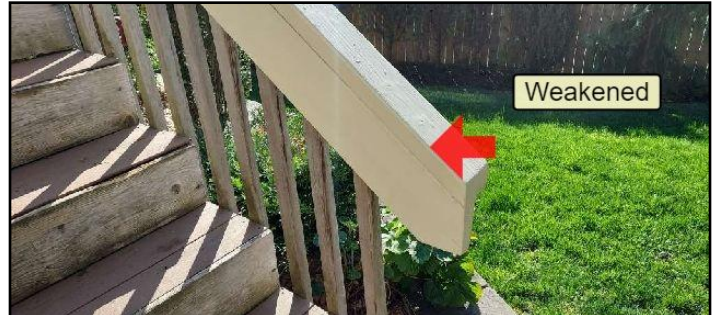
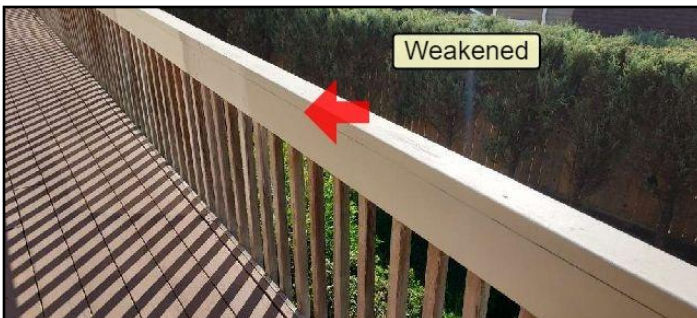
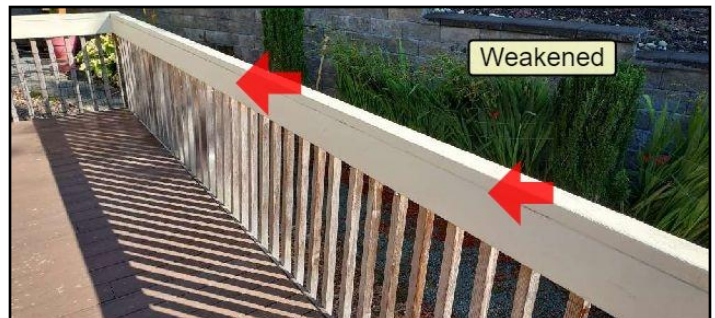
4. Condition: • [Weak](#)

Implication(s): Fall hazard

Location: Various locations of exterior railings

Weak

Task: Improve Support

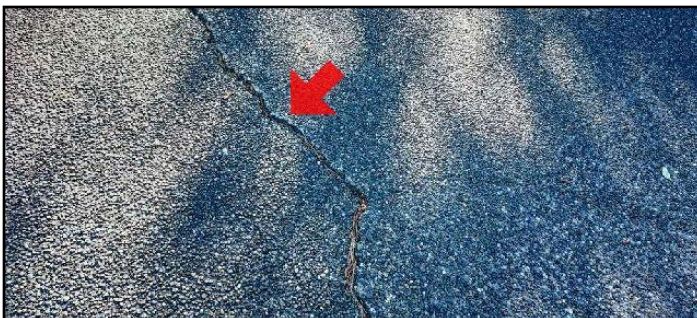
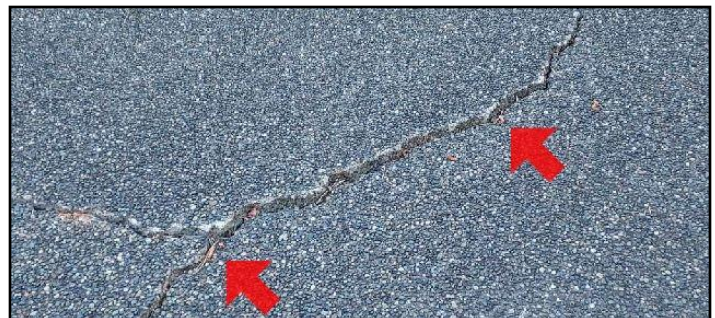
5. Condition: • Cracked or damaged surfaces

Implication(s): Trip or fall hazard | Chance of weakened structure

Location: Front Exterior Driveway

Cracked or damaged surfaces

Task: Repair

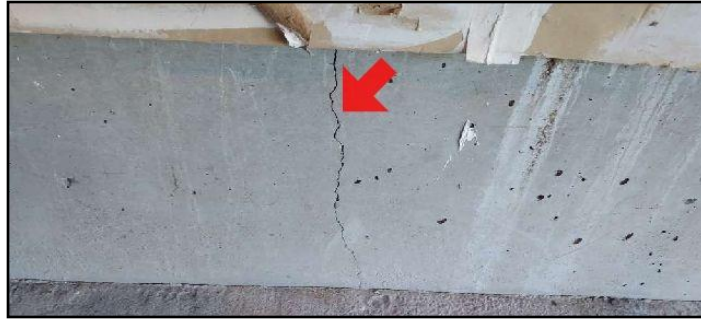
**6. Condition:** • Typical minor cracks

**Implication(s):** Chance of water entering building

**Location:** Garage

*Typical minor cracks*

**Task:** Monitor and Repair

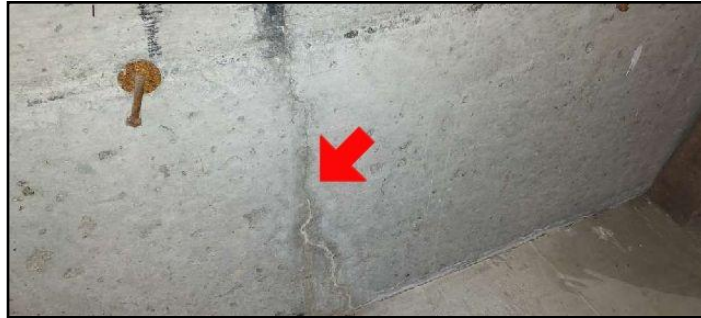
**7. Condition:** • Minor foundation crack with water stains

**Implication(s):** Chance of weakened structure

**Location:** Garage

**Task:** Repair

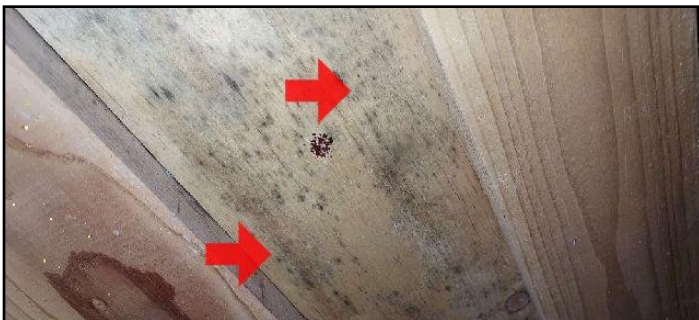
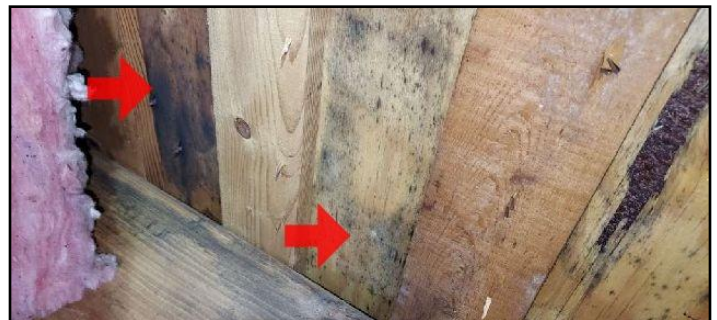
**8. Condition:** • There is evidence of a mold-like substance growing on the underside of the roof sheathing visible from the attic. A mold mitigation company needs to be hired to further inspect the substance and make any needed repairs to include treating and sealing.

**Implication(s):** Material Deterioration / Health Hazard

**Location:** Various Locations of Attic

*There is evidence of a mold-like substance...*

**Task:** Service

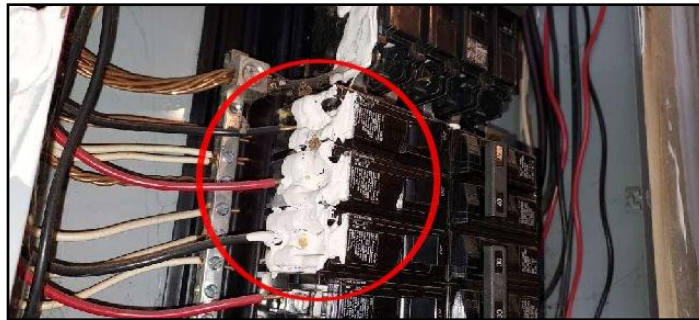
**9. Condition:** • Foreign material (possibly drywall compound) on Breakers and Connections

**Task:** Remove

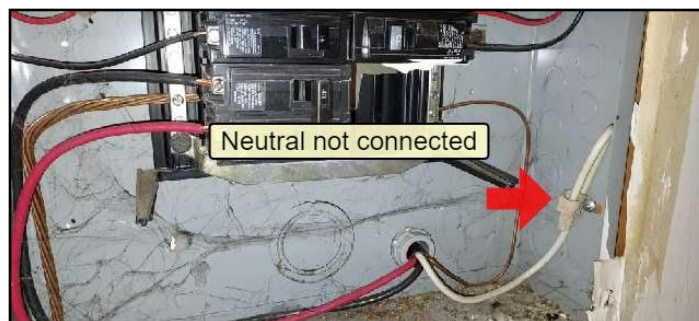
**10. Condition:** • Neutral wire for Furnace Circuit not connected to bus. A qualified electrician should be hired to include all necessary repairs or corrections.

**Implication(s):** Chance of Electrical Shock

**Location:** Distribution Panel

**Task:** Further evaluation

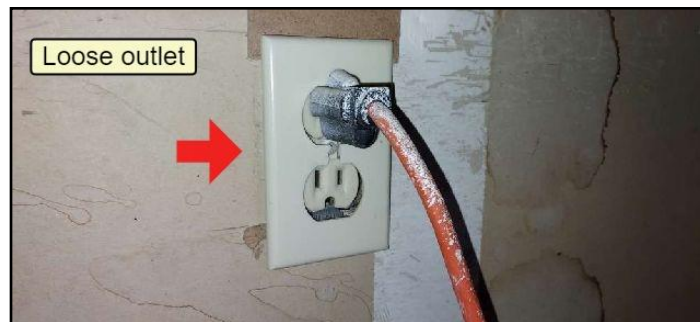
**11. Condition:** • [Loose](#)

**Implication(s):** Electric shock | Fire hazard

**Location:** Garage

*Loose*

**Task:** Repair

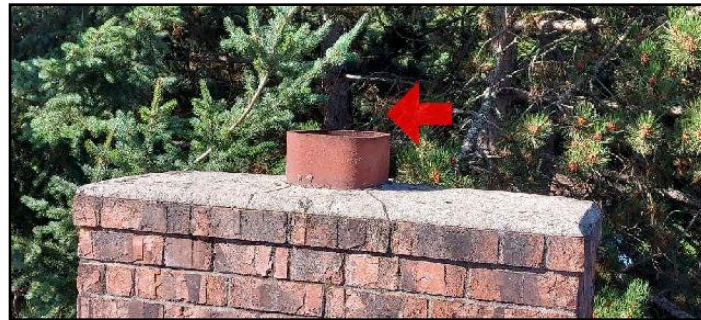
**16. Condition:** • Spark Arrestor Missing

**Implication(s):** Chance of fire to surrounding exterior vegetation and / or building materials

**Location:** Chimney

*Spark Arrester Missing*

**Task:** Provide

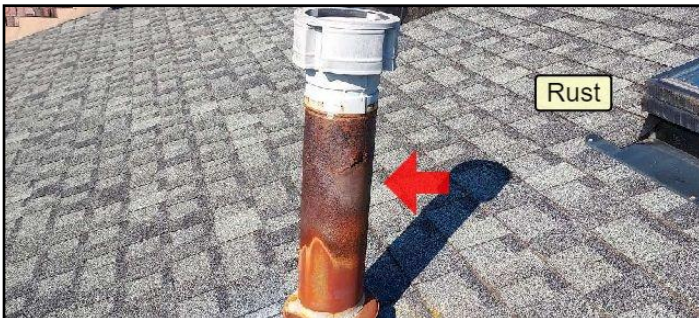
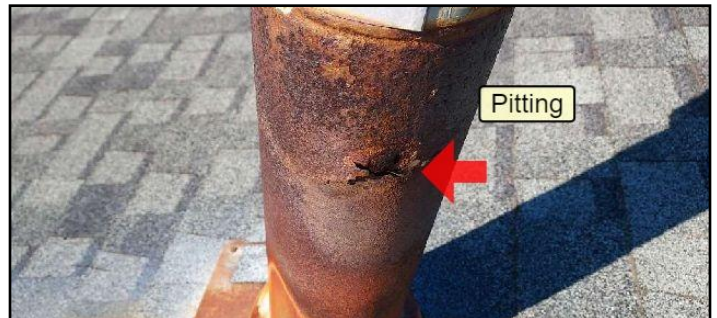
**17. Condition:** • [Chimney walls rusting or pitting](#)

**Implication(s):** Chance of movement | Hazardous combustion products entering home

**Location:** Exterior Roof

*Chimney walls rusting or pitting*

**Task:** Replace

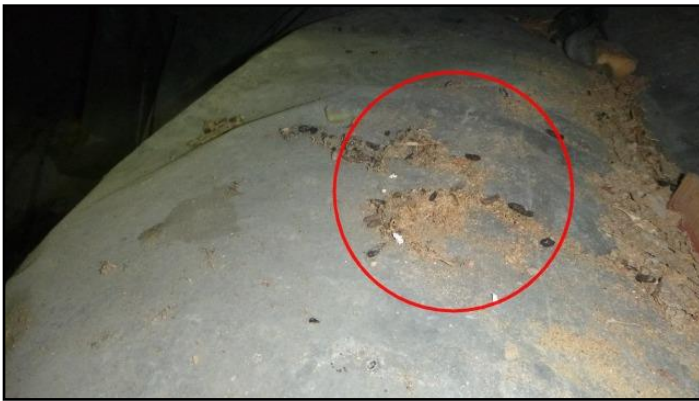
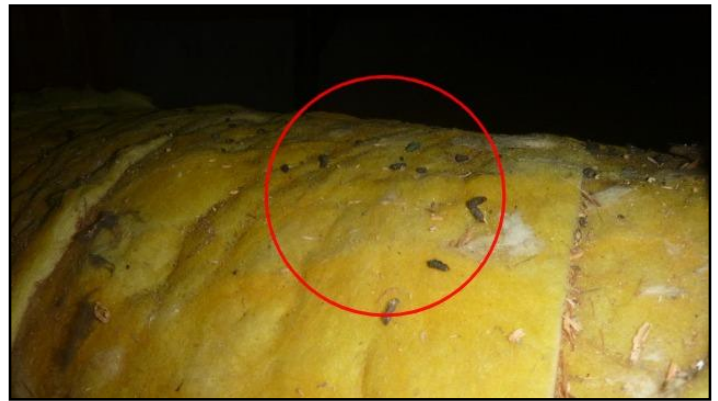
**20. Condition:** • Animal/pest droppings in crawlspace

There was evidence of rodent/animal activity within crawlspace. This can present a long term hygienic concern and potentially a health hazard. I recommend consultation with a qualified rodent/extermination contractor to include service, cleaning and proper sealing to minimize entrance points as necessary.

**Implication(s):** Health Hazard

Animal/pest droppings in crawlspace

**Task:** Service

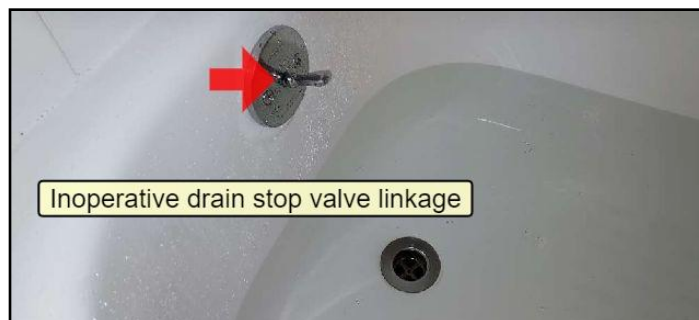
**22. Condition:** • Drain Stop Broken

**Implication(s):** Bathtub does not drain properly

**Location:** Second Floor Hallway Bathroom

**Task:** Repair

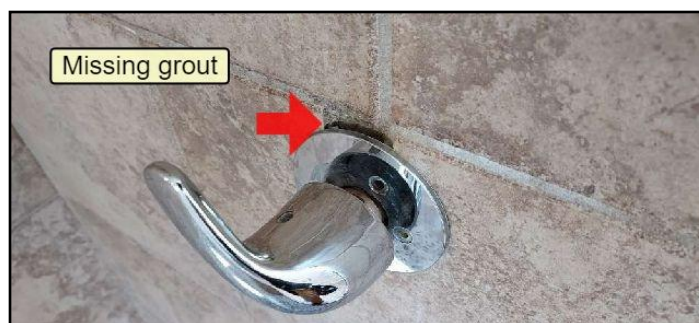
**23. Condition:** • [Grout loose, missing or deteriorated](#)

**Implication(s):** Chance of water damage to structure, finishes and contents

**Location:** Second Floor Master Bathroom Shower

*Grout loose, missing or deteriorated*

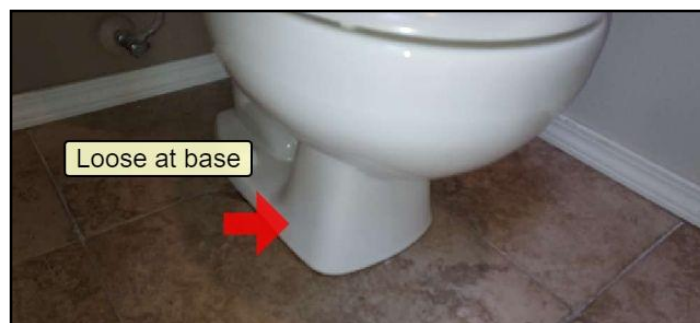
**24. Condition:** • The toilet was loose and not properly secured. The toilet should be removed and the sub-flooring

should be inspected for potential water damage. The unit should have a new seal installed and then the toilet should be properly secured.

**Implication(s):** Chance of water damage to structure, finishes and contents | Sewage entering the building | Possible hidden damage

**Location:** Second Floor Master Bathroom

*Loose at base*

**Task:** Correct

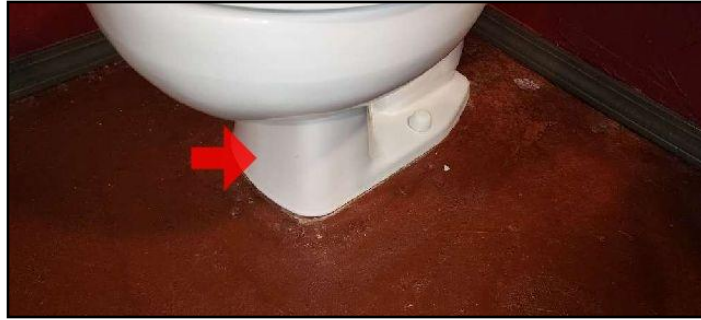
**25. Condition:** • Loose at base

**Implication(s):** Chance of water damage to interior, finish or structure

**Location:** Basement Bathroom

*Loose at base*

**Task:** Correct

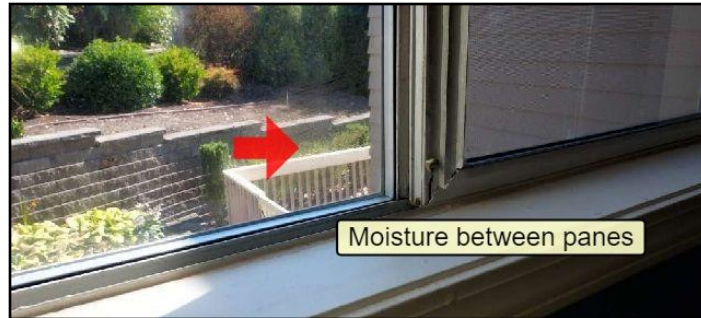
**26. Condition:** • Lost seal on double or triple glazing

**Implication(s):** Shortened life expectancy of material | Chance of water damage to interior, finish or structure

*Lost seal on double or triple glazing*

**Task:** Repair or replace

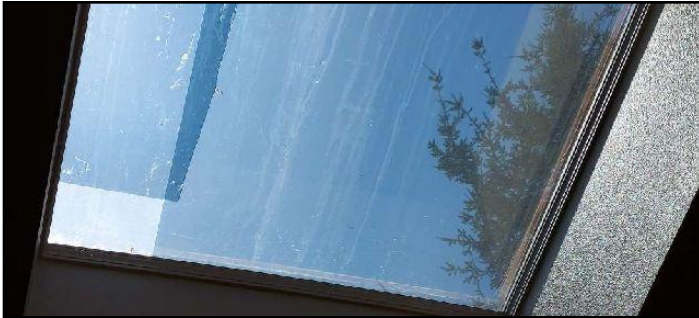
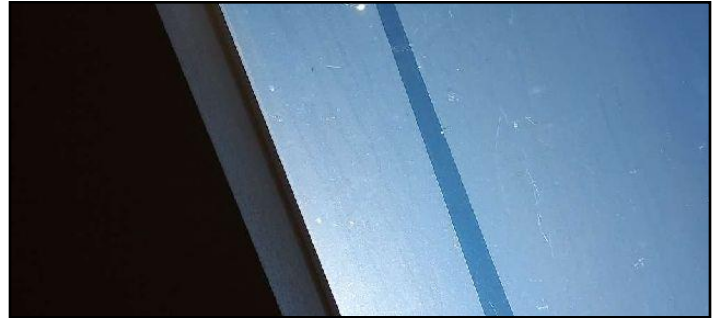
**27. Condition:** • Lost seal on double or triple glazing

**Implication(s):** Shortened life expectancy of material | Chance of water damage to interior, finish or structure

**Location:** Skylights

*Lost seal on double or triple glazing*

**Task:** Repair or replace

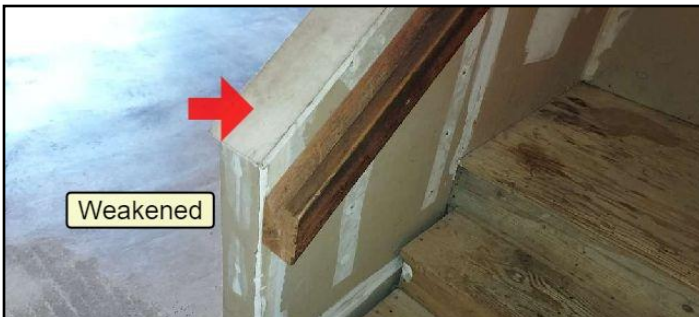
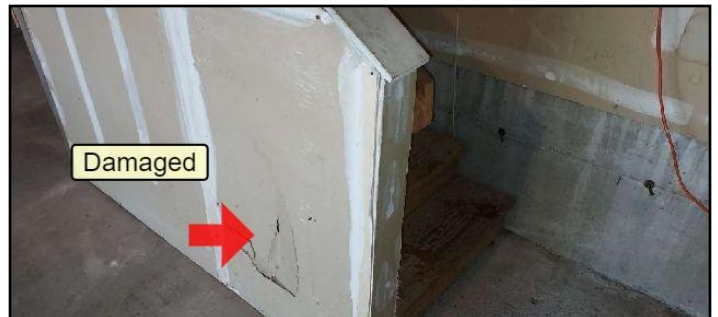
**28. Condition:** • Weak

**Implication(s):** Fall Hazard

**Location:** Garage Staircase

*Weak*

**Task:** Improve Stability
