# Your Inspection Report

Thursday, July 27, 2023

HomeBridge Inspections LLC  
Tacoma, WA 98409

RE: Report No. 2704, v.2

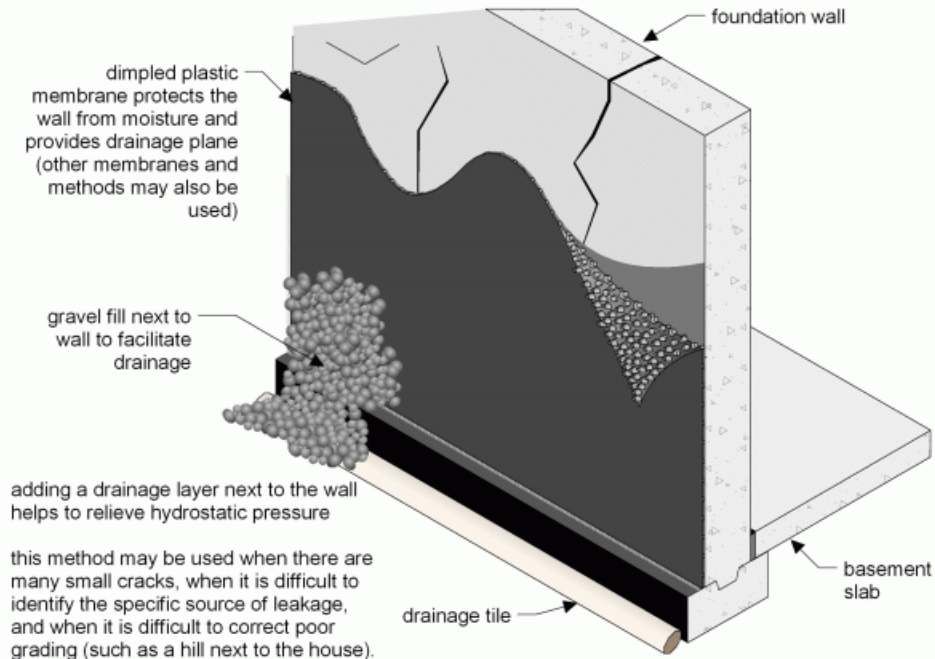
## Crack repair - drainage layer

**6. Condition:** • Typical minor cracks

**Task:** Monitor and Repair

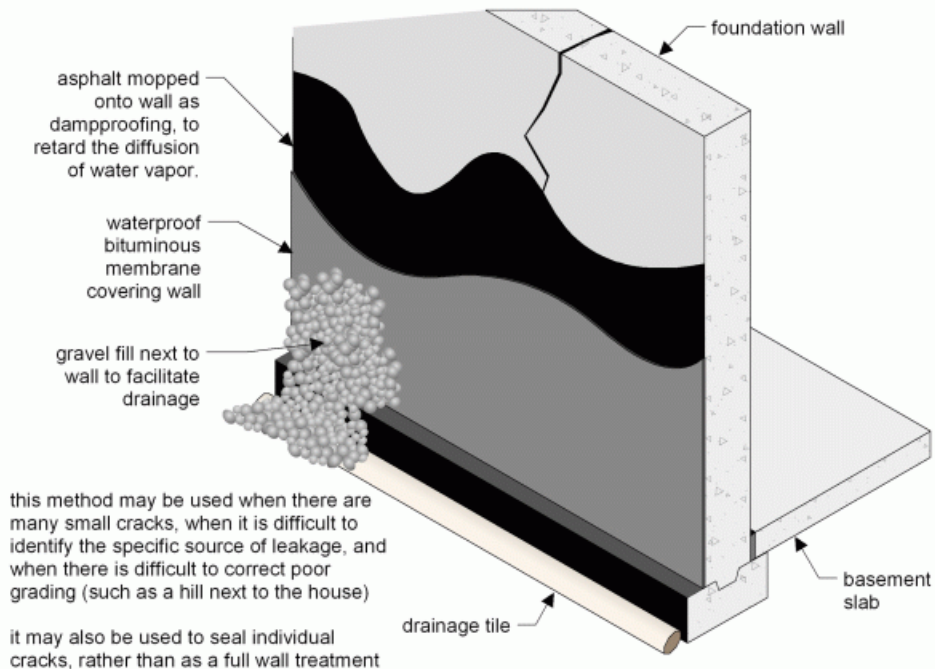
## Crack repair - exterior patching

*Typical minor cracks*

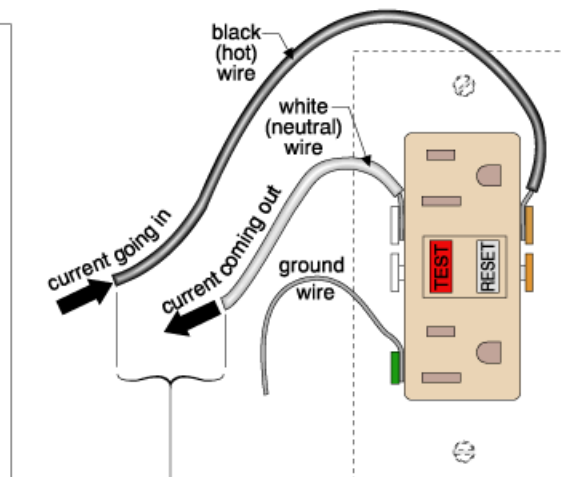
**12. Condition:** • There were no AFCI receptacles or breakers observed within the property. AFCI protection was not a common practice during this era of home construction. It is recommended to have AFCI protection installed according to industry standards.

**Implication(s):** Fire hazard

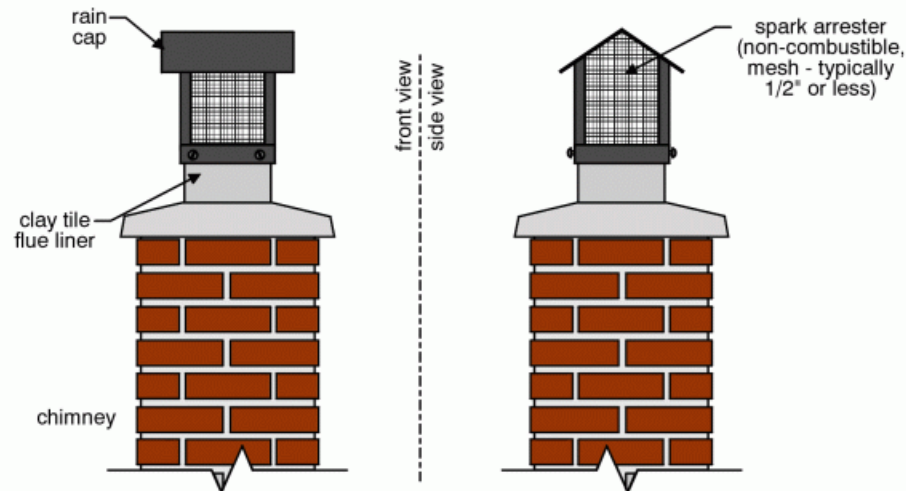
## Rain caps and spark arresters

**16. Condition:** • Spark Arrestor Missing

*Spark Arrester Missing*

**Task:** Provide

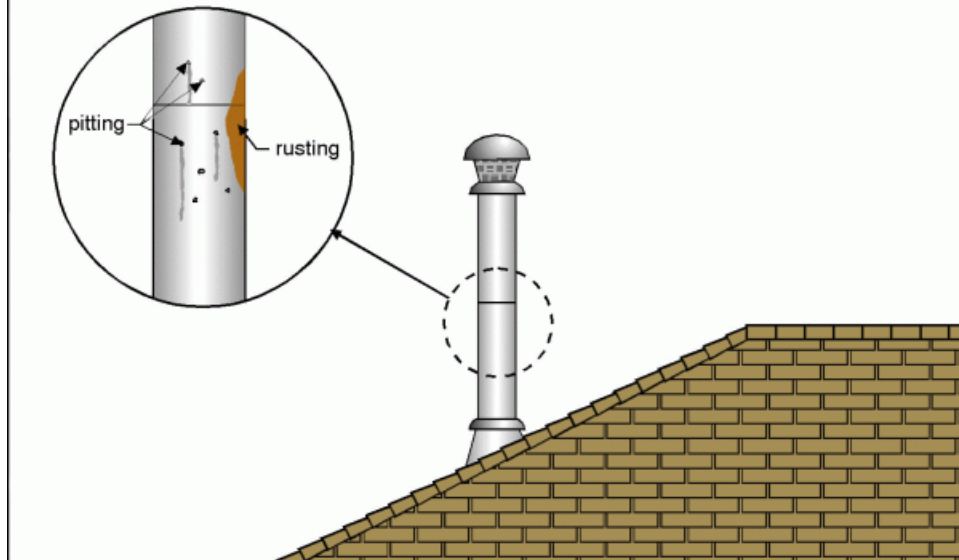
## Rusting and/or pitting metal chimneys

**17. Condition:** • [Chimney walls rusting or pitting](#)

**Implication(s):** Chance of movement | Hazardous combustion products entering home

*Chimney walls rusting or pitting*

**Task:** Replace
